"Full" Reserve Study

The Villages at Aviano Phoenix, AZ

Report #: 12116-1
For Period Beginning: January 1, 2020
Expires: December 31, 2020

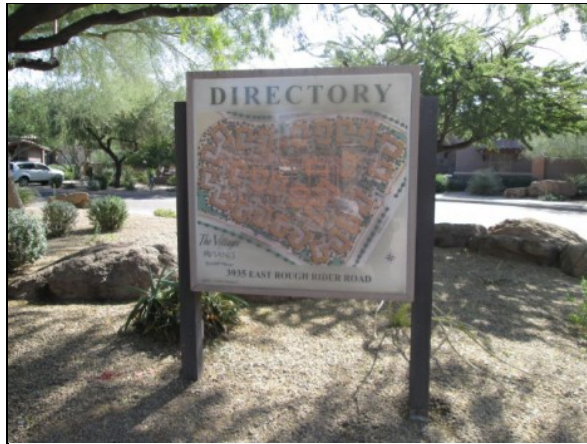
Comp #: 101 Community Map - Replace (A)

Comments: Observed to be older with heavy weathering. Overall, this community map is in poor shape.

Useful Life:
15 years

Remaining Life:
0 years
