"Full" Reserve Study

The Villages at Aviano Phoenix, AZ

Report #: 12116-1
For Period Beginning: January 1, 2020
Expires: December 31, 2020

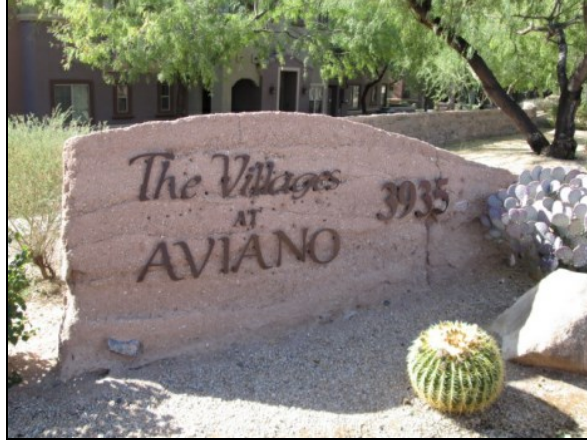
Useful Life:
20 years

Remaining Life:
5 years

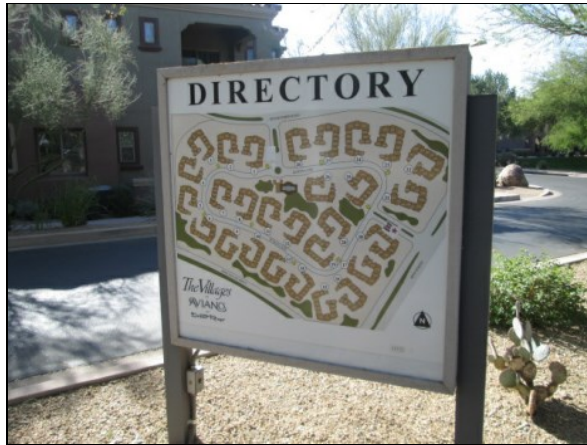
Comp #: 101 Community Map - Replace (A)

Comments: Observed to be older with heavy weathering. Overall, this community map is in poor shape.

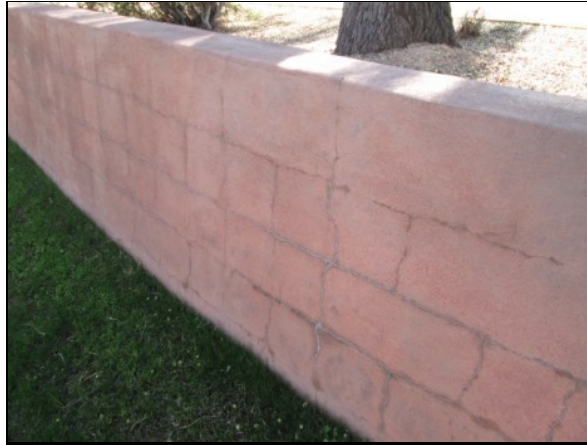
Comp #: 501 Block/Stucco Walls - Repair

Comments: Walls are expected to last the life of the community under normal circumstances. This component funds an allowance for repairs and/or partial replacement due to excessive settling or other sources of damage.

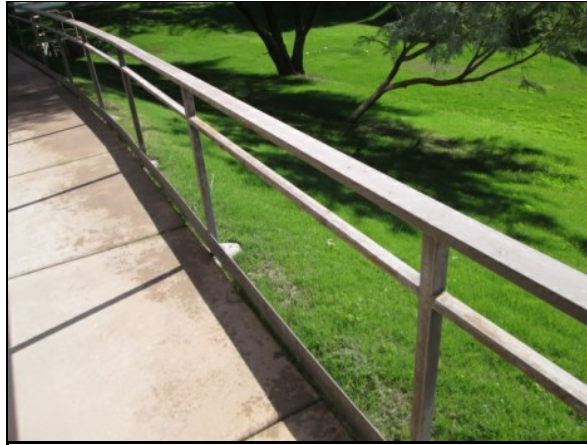
Comp #: 504 Metal Rails - Replace

Comments: Some rust and oxidation evident. Overall, fair conditions were observed. Future replacement should be anticipated.

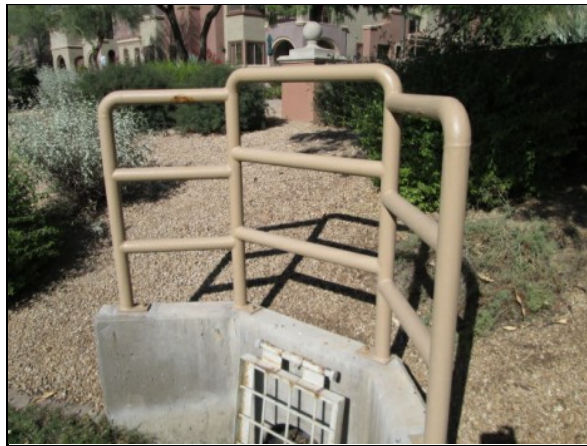
Comp #: 505 Culvert Rails - Replace

Funded?: No. This component has an extended life span with no expectancy to replace in the foreseeable future.

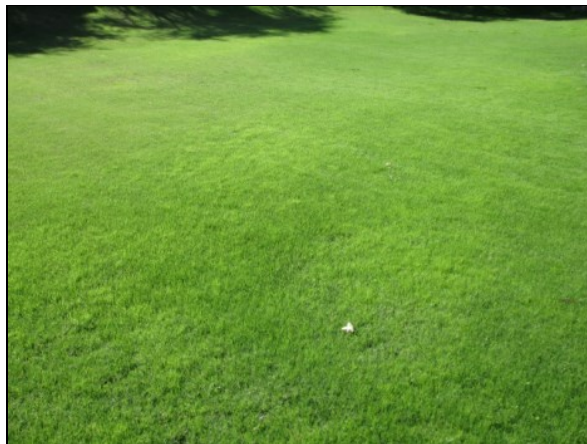
Comp #: 600 Irrigation System - Replace

Funded?: No. It is beyond the scope of this Reserve Study to quantify and assess conditions of the irrigation system. Funding can be provided for future replacement at the client's request, but we would need to be provided with cost and life expectancy estimates. Repairs and partial replacements should be included in the annual landscape maintenance budget.

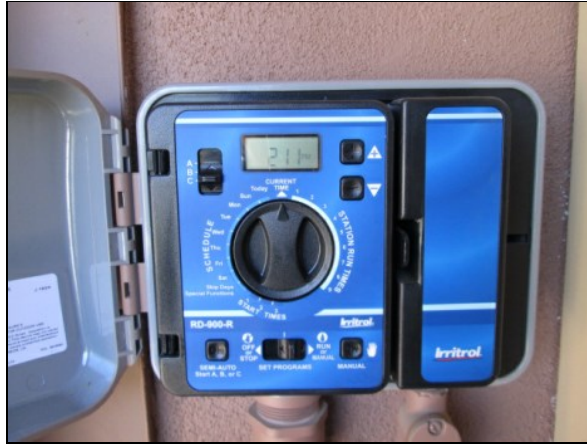
Comp #: 610 Irrigation Controllers - Replace

Funded?: No. Controllers vary in age. Individual costs are below the Reserve expense threshold. Recommend replacing as needed with Operating funds.

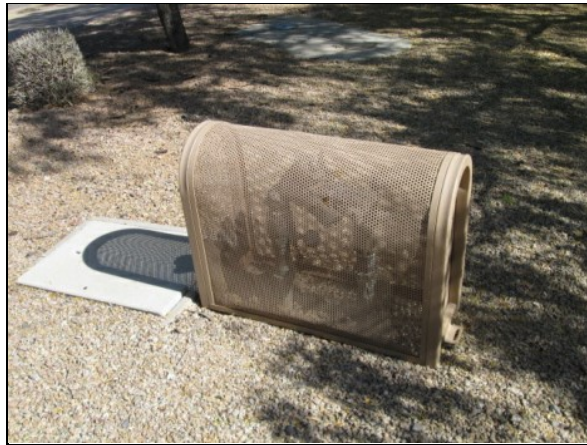
Comp #: 630 Backflow Valves - Replace

Funded?: No. These are small backflow valves that can often be repaired and rebuilt rather than replaced. Recommend repairing or replacing as needed with Operating funds.

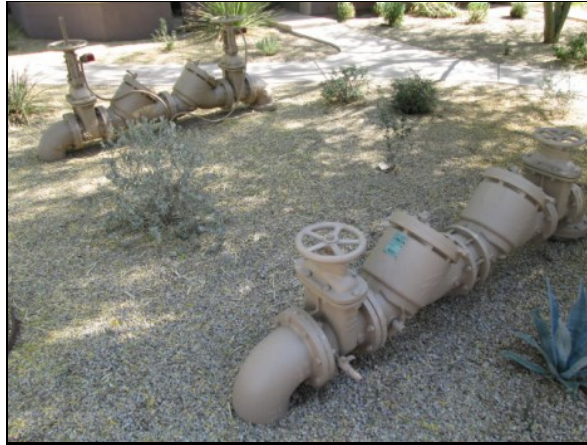
Comp #: 630 Backflow Valves - Replace (2005)

Comments: These are large, rather expensive backflow valves. It would be prudent to plan for eventual replacement as a Reserve expense. Assumed to be functional.

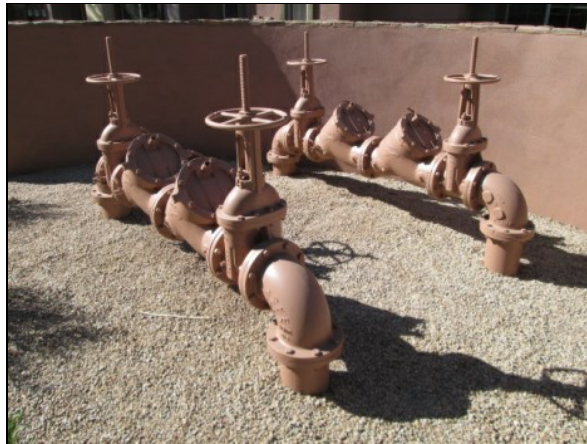
Comp #: 630 Backflow Valves - Replace (2017)

Comments: These are large, rather expensive backflow valves. It would be prudent to plan for eventual replacement as a Reserve expense. Assumed to be functional.

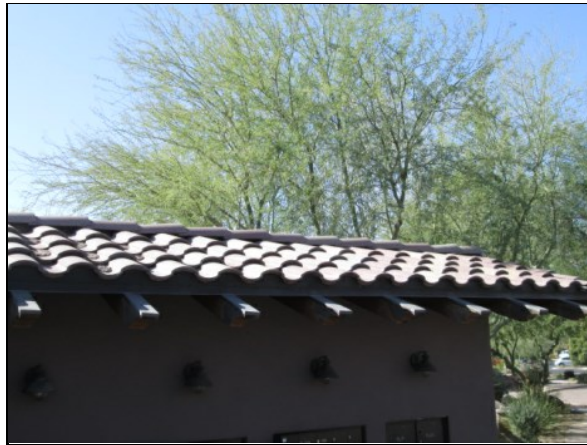
Comments: There is no expectancy to replace all of the tiles under normal circumstances. Replacement of the felt paper underlayment should be anticipated eventually. Life span will vary depending on the quality of underlayment installed.

Recommend including with the Phase 1 unit building tile roof refurbishment project to achieve a discounted cost, as budgeted.

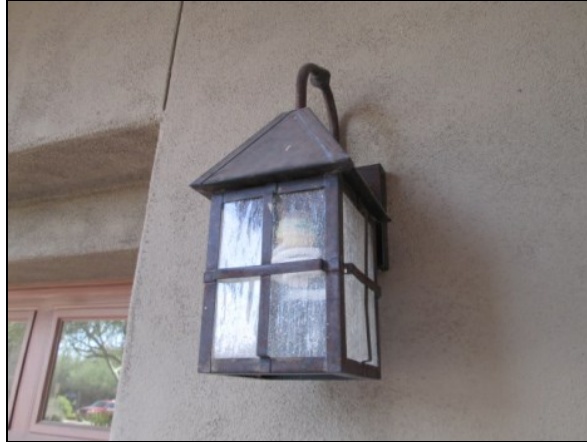
Comp #: 900 Exterior Lights - Replace (Ph1)

Comments: Appear to be functional and in generally in fair shape. Some lights have considerable rust evident. Complete replacement should be anticipated to restore the appearance and maintain uniformity. Repair and replace individual lights as needed with Operating funds.

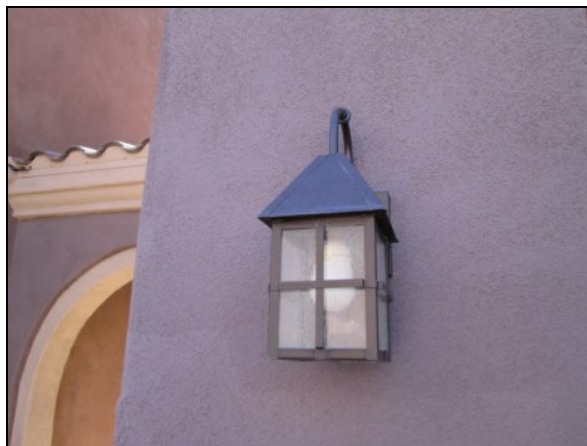
Comp #: 900 Exterior Lights - Replace (Ph2)

Comments: Appear to be functional and in generally in fair shape. Some lights have considerable rust evident. Complete replacement should be anticipated to restore the appearance and maintain uniformity. Repair and replace individual lights as needed with Operating funds.

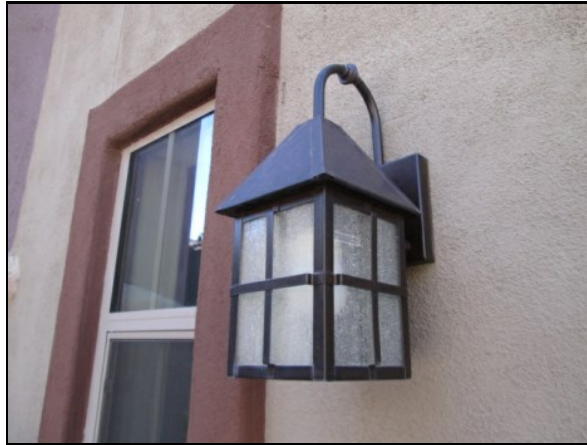
Comp #: 900 Exterior Lights - Replace (Ph3)

Comments: Appear to be functional and in good shape. Complete replacement should be anticipated to restore the appearance and maintain uniformity. Repair and replace individual lights as needed with Operating funds.

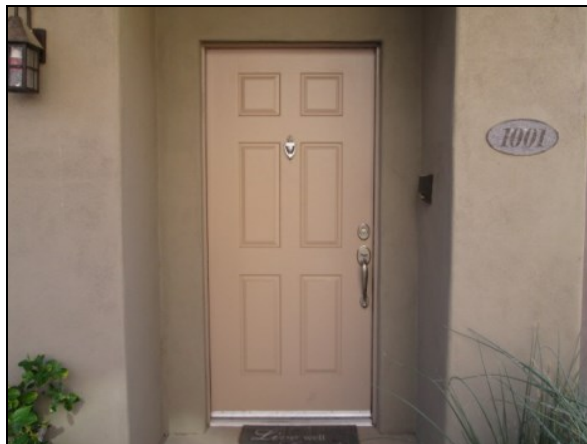
Comp #: 910 Front Doors - Replace

Funded?: No. Replacement of unit front doors are each owner's responsibility, not the HOA.

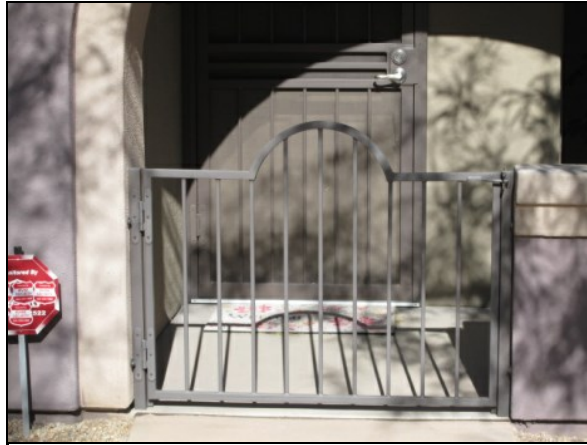
Comp #: 911 Patio Gates - Replace

Funded?: No. Replacement of unit patio gates are each owner's responsibility, not the HOA.

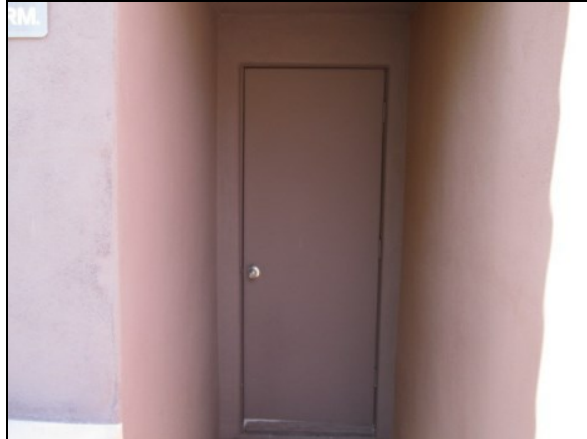
Comp #: 912 Utility Doors - Replace (Ph1)

Comments: Observed to be intact, functional and in fair shape. Future replacement should be anticipated.

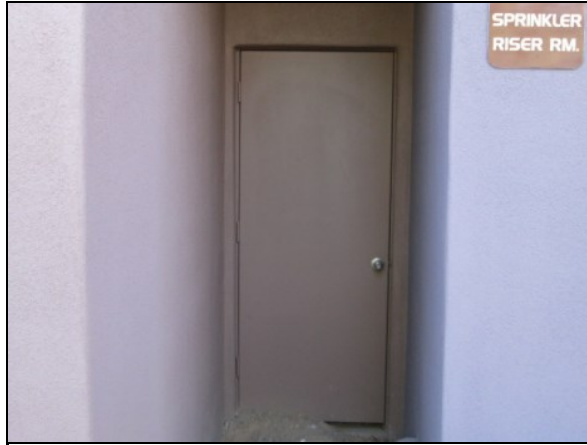
Comp #: 912 Utility Doors - Replace (Ph2)

Comments: Observed to be intact, functional and in fair shape. Future replacement should be anticipated.

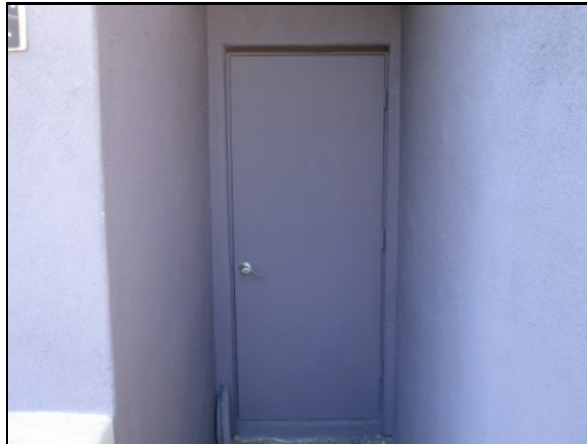
Comp #: 912 Utility Doors - Replace (Ph3)

Comments: Observed to be intact, functional and in good shape. Future replacement should be anticipated.

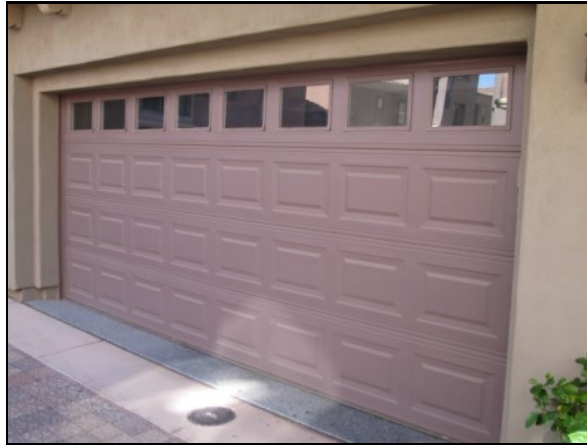
Comp #: 914 Garage Doors - Replace (Ph1)

Comments: The HOA is reportedly responsible for replacement of the unit garage doors. Garage doors are long life items, but they will eventually look aged and worn. Overall, fair conditions were observed.

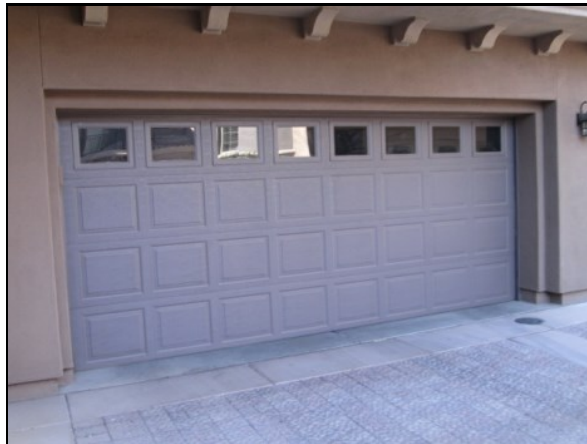
Comp #: 914 Garage Doors - Replace (Ph2)

Comments: The HOA is reportedly responsible for replacement of the unit garage doors. Garage doors are long life items, but they will eventually look aged and worn. Overall, fair conditions were observed.

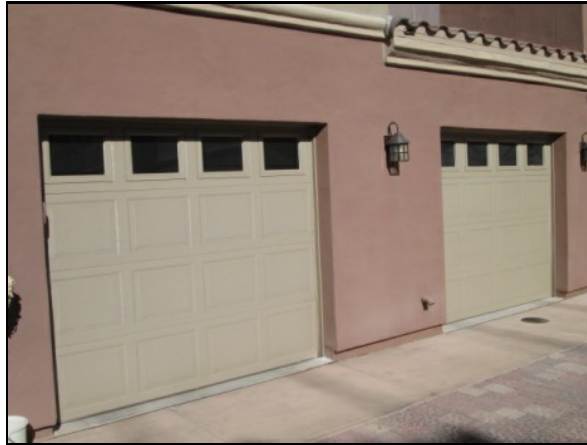
Comp #: 914 Garage Doors - Replace (Ph3)

Comments: The HOA is reportedly responsible for replacement of the unit garage doors. Garage doors are long life items, but they will eventually look aged and worn. Overall, good conditions were observed.

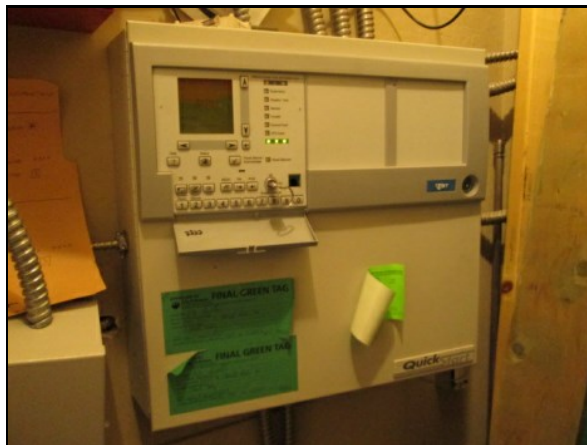
Comments: We are not authorized to test or inspect the fire alarm system. It should be professionally inspected as required by local fire codes. It is prudent to plan for modernization of the fire alarm system as it was originally installed around 2005. The extent of a modernization can vary widely, so an allowance has been provided. We recommend hiring a qualified vendor to assess the system to provide a scope and estimate to implement in a future update to this report.

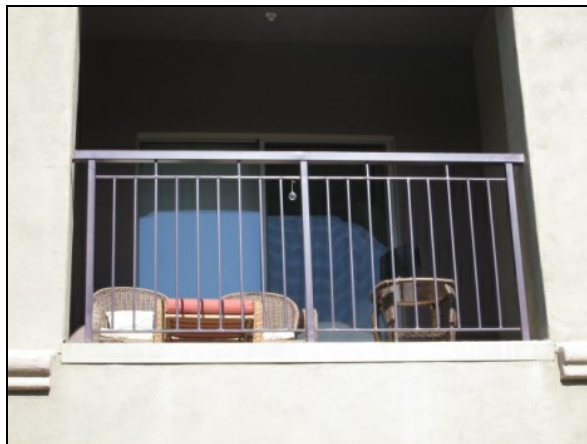
Comp #: 962 Balcony Rails - Replace

Funded?: No. This component has an extended life span with no expectancy to replace in the foreseeable future.

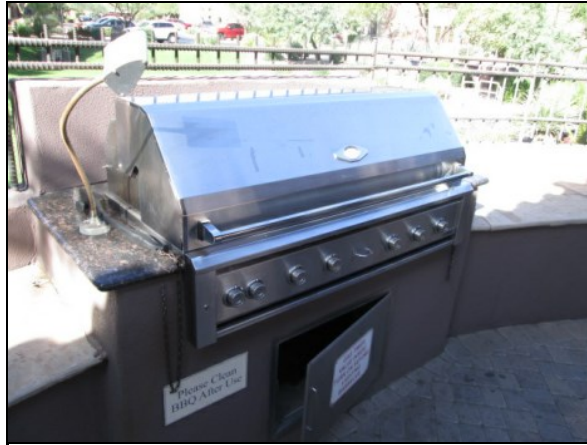
Comp #: 1130 BBQ Grill - Replace

History: Scheduled to be replaced during 2022. Replaced during 2016. Previously original from around 2005.

Comments: This is a 54" 7-burner gas grill. Observed to be clean and in good shape.

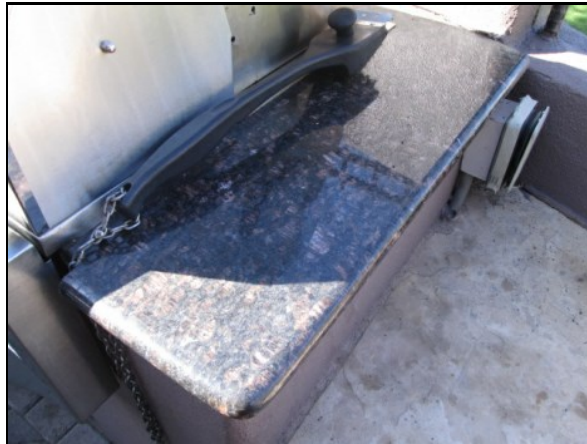
Comp #: 1132 Granite Counters - Replace

History: Scheduled to be replaced during 2022. Installed around 2005.

Comments: Observed to be intact and in fair shape. Future replacement should be anticipated.

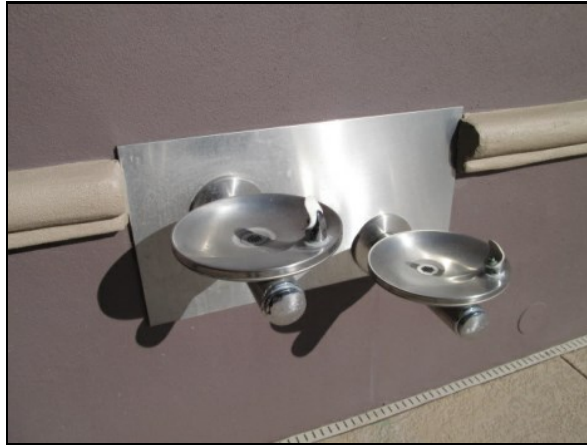
Comp #: 1135 Drinking Fountain - Replace

Comments: This is a SwirlFlo Series ADA Bi-Level drinking fountain. Some wear and weathering evident, but still functional overall.

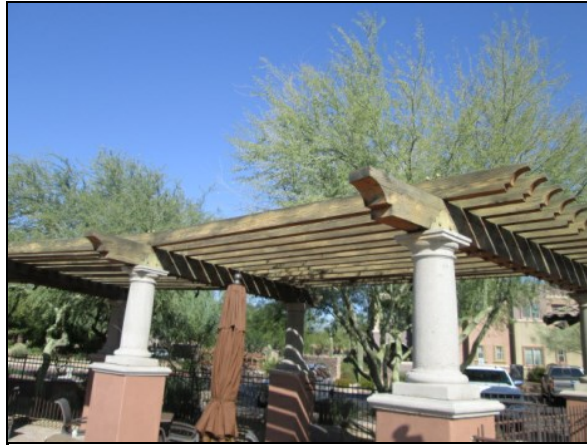
Comp #: 1150 Wood Pergola - Replace

Comments: Observed to be intact, secure and in fair shape. Some splitting evident. Future replacement should be anticipated.

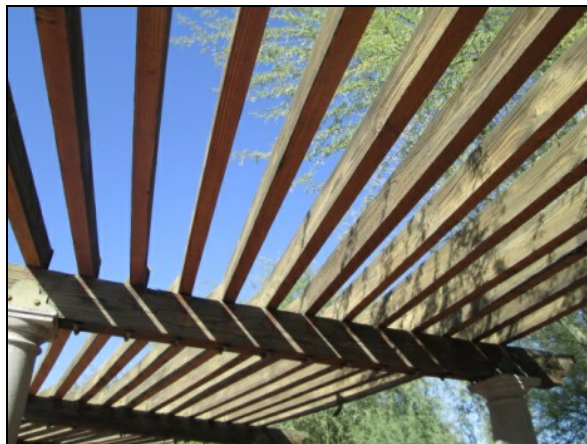
Comp #: 1152 Wood Pergola - Seal/Stain

Comments: Observed to be heavily faded and worn. The wood pergola has high sun exposure therefore will need to be repainted more frequently.

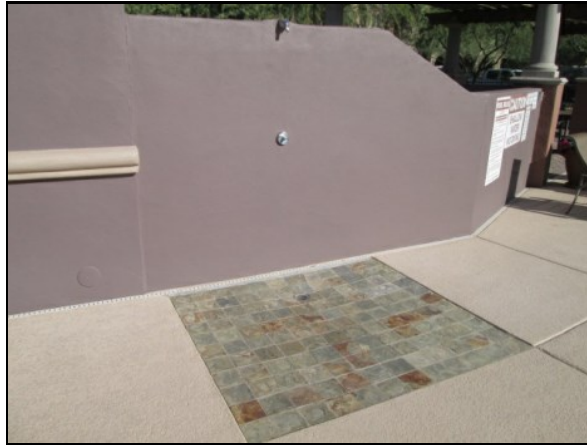
Comments: Pool shower consists of (1) shower faucet and 36 Sq Ft of tile. Funding to replace the pool shower tile is included with the pool deck resurface.

Funded?: No. Cost is below the Reserve expense threshold. Recommend refurbishing as needed with Operating funds.

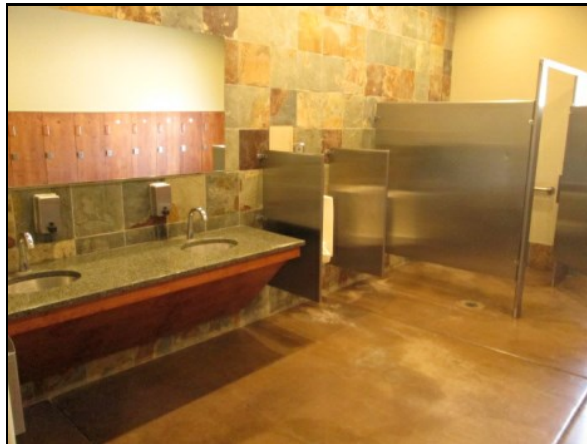
Comments: Observed to still be modern and attractive. Overall, fair conditions were observed. This component funds to remodel the pool restroom eventually, which includes replacement of the toilets, urinals, sinks, wall tiles, lights, mirrors, lockers, paint, etc. Funding to periodically repaint the pool restroom interiors is included with the stucco repainting projects.

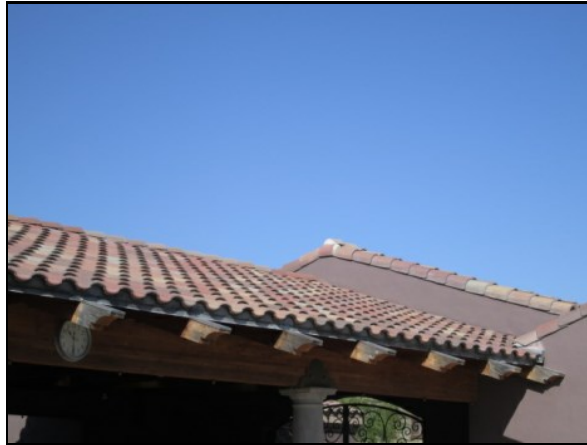
Comments: There is no expectancy to replace all of the tiles under normal circumstances. Replacement of the felt paper underlayment should be anticipated eventually. Life span will vary depending on the quality of underlayment installed.

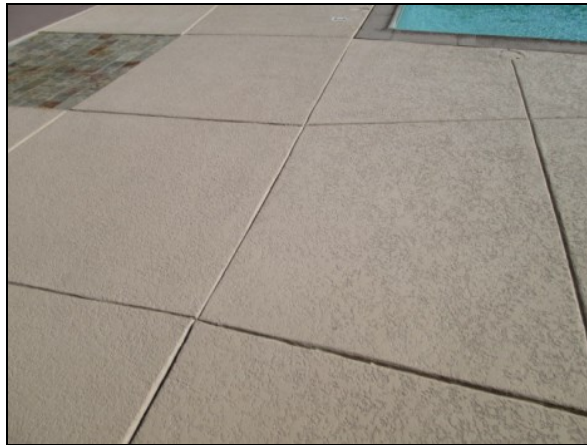
Location: Pool area (includes replacement of the pool shower tile)

Comments: Observed to be intact and in good condition. This component funds to periodically grind off the existing deck coating and re-apply a new surface. Combined cost with the seal/repair component accounts for the total estimated resurface budget. Remaining life reflects current condition, not actual age.

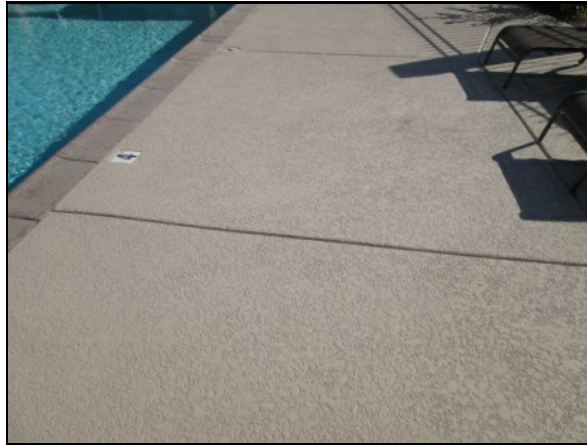
Comp #: 1201 Pool Deck - Seal/Repair

Comments: Some staining and discoloration evident. This component funds to periodically patch cracks and seal/paint the deck to cover stains and restore the appearance.

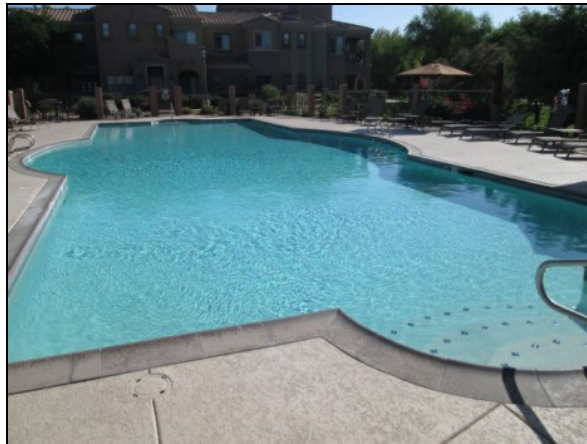
Comments: Pool has a pebble surface. Observed to be intact and in good shape.

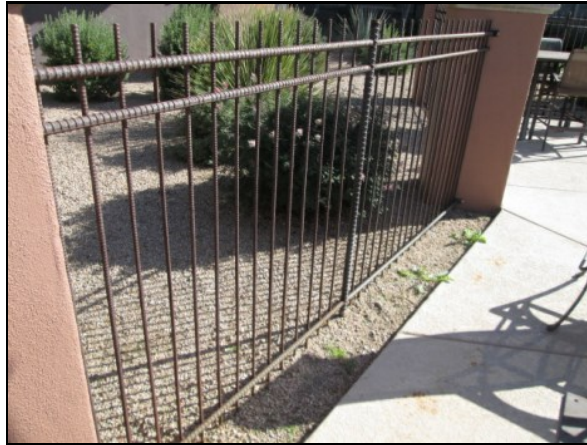
Comp #: 1215 Pool Fence - Replace

Comments: There is approximately 265 LF of 5' tall and 35 LF of 2' tall fence. This is unpainted rebar fencing. Observed to be intact and in fair shape. Some rust evident. Future replacement should be anticipated.

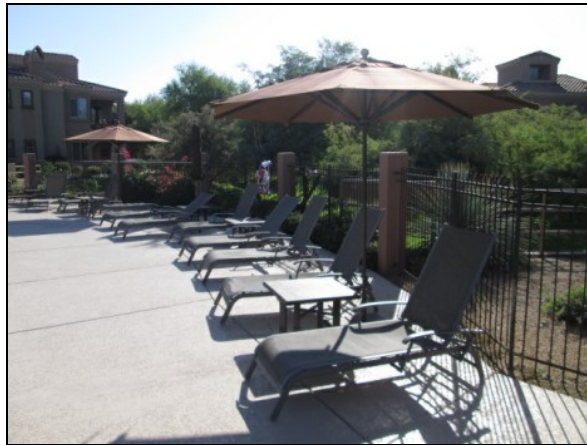
Comp #: 1220 Pool Furniture - Replace

History: Reportedly replaced slings during 2018.

Comments: Pieces include (28) lounges with slings, (54) chairs with slings, (9) chairs with cushions, (15) tea tables, (13) dining tables and (6) umbrellas. Appear to be functional and in fair shape overall. Some wear and weathering evident. Complete replacement should be anticipated to restore the appearance and maintain uniformity.

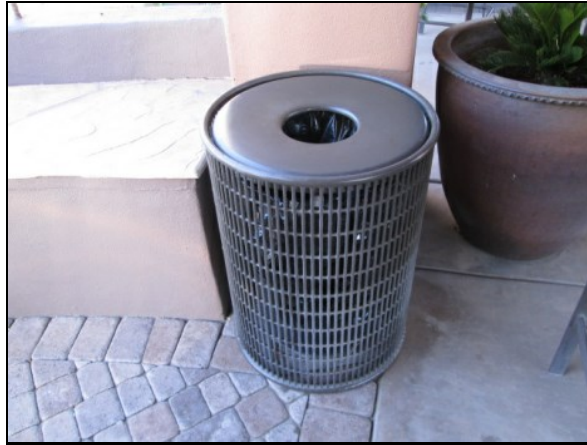
Comp #: 1222 Trash Cans - Replace

Comments: Observed to be functional and in fair shape.

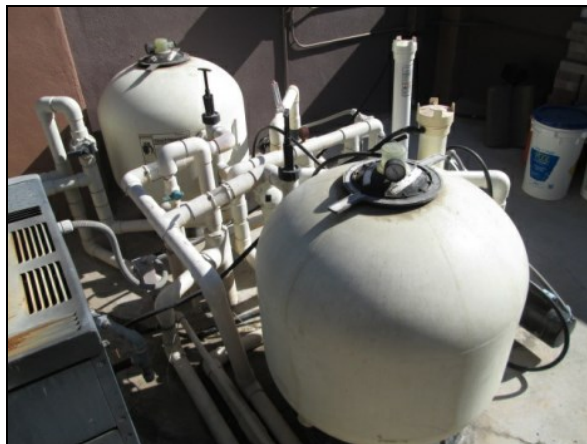
Comp #: 1240 Pool Filters - Replace

Comments: Observed to be older, worn and weathered. Based on age, replacement should be anticipated.
